TECHNICAL BULLETIN

POINT BLANK 2

Two problems have been identified on games with the following serial numbers:-

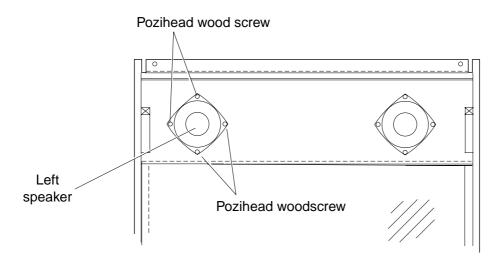
The loudspeakers have been wired 'out of phase' resulting in a loss of bass tone.

3. Remove 4off pozi head wood screws and remove the left speaker only sufficiently to access the speaker connections.

Note: Take care not to damage the speaker cone.

- 4. Disconnect the speaker.
- 5. Cut off the 0.110" (smallest) receptacle from the white/violet wire and replace it with the supplied 0.187" receptacle.
- 6. Cut off the 0.187" receptacle from the white/red wire and replace it with the supplied 0.110" receptacle.
- 7. Reconnect the speaker and reassemble in reverse order.

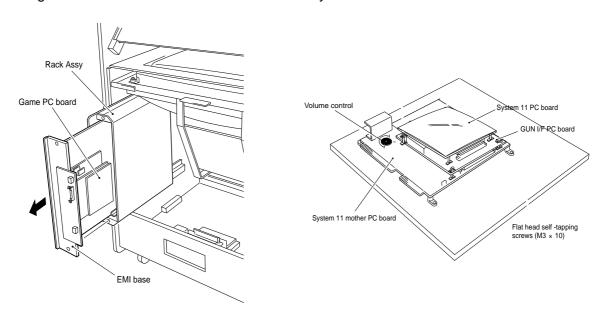
The master volume has been set too low.

10. Carefully withdraw the game pcb assembly from the rack assembly only sufficient to gain access to the volume control on the System 11 Mother PC Board.

- 11. Turn the volume control clockwise to approx 3/4 of its travel.
- 12. Ensure that the System 11 Mother PC Board edge connection is fully seated in the edge connector housing of the EMI PC Board and reassemble in reverse order.
