TECHNICAL BULLETIN

POINT BLANK 2

Two problems have been identified on games with the following serial numbers:-

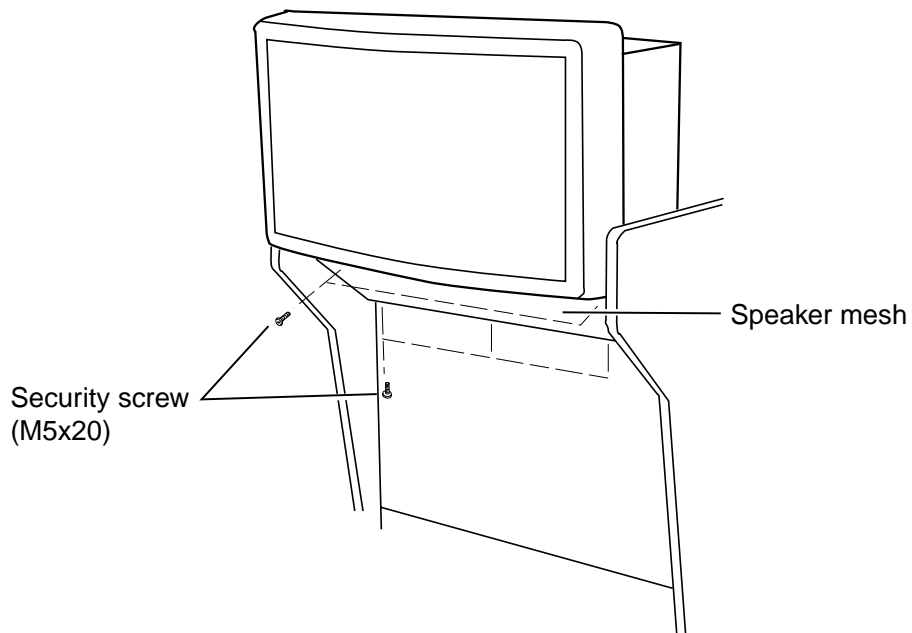
The loudspeakers have been wired 'out of phase' resulting in a loss of bass tone.

1. **SWITCH THE GAME OFF.**
2. Remove 5 off security screw (M5x20) and remove the speaker mesh.

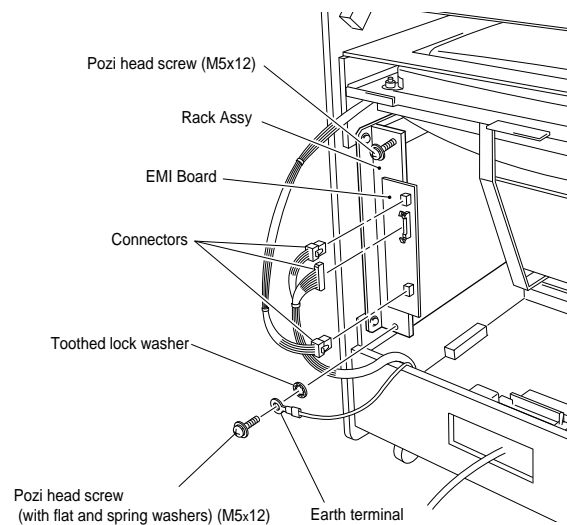
The master volume has been set too low.

8. Open the back door and disconnect the connectors from the EMI Board.
9. Remove 2 off pozi head screws (M5x12) from the rack assembly, taking care not to lose the toothed washer behind the earth terminal.

NOTE: Ensure that the earth terminal is refitted, with toothed washer, when reassembling.
